Z1349 Trouble-shooting Guide

Z1349 Narrow Wall Hydrant

Exposed • Moderate Climate

Maintenance and Service Instructions

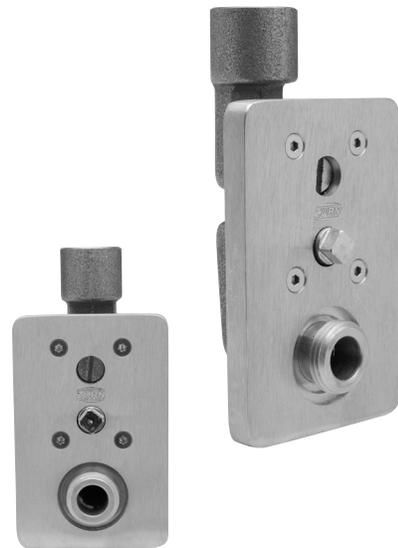
The Zurn Hydrant has been engineered to provide reliable performance year after year. However, if servicing is required, it is recommended that you consult the trouble-shooting guide at the left. The trouble-shooting guide was developed to reduce maintenance time by providing the user with appropriate service instructions.

Using a flat screwdriver, shut off the water supply by turning the stop plunger assembly (3) clockwise until the water supply is off.

Using 1/8 Allen wrench, remove the four faceplate screws (10) from head (1) by turning counter clock-wise. Remove the faceplate (6),

The internal operating plunger assembly (2, 4, 5 and 8) can be removed by using the key (15) on the square end of the operating plunger (2) and turning counter clockwise until the operating plunger assembly (2) is unscrewed from head (1). Discard the operating plunger assembly

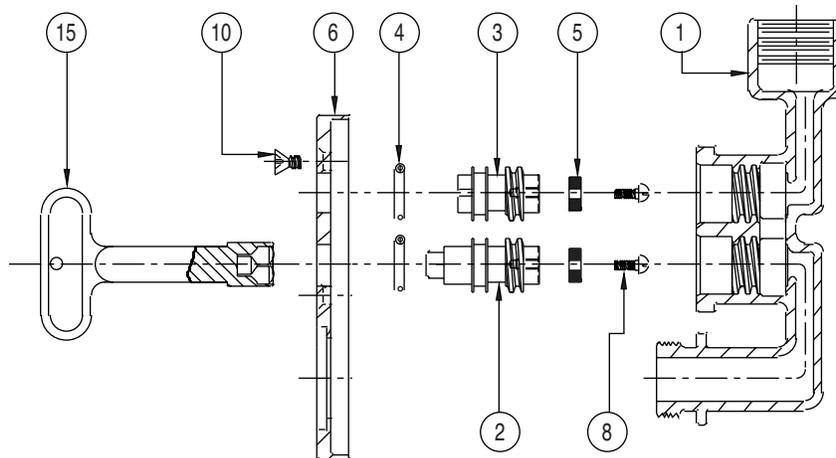
Insert the new operating plunger assembly (2) into the head (1), and using the key (15) turn clockwise until seated snug. (By hand only.) (Note: Lubricate the “O” Ring (4) with Lubriplate FGL-2 if needed).

Place the faceplate (6) onto head (1), and using the 1/8” Allen wrench and the four screws (10) rotate the screws clockwise until screws are snugged tight. (By hand only.)

Using a flat screwdriver, turn on the water supply by turning the stop plunger assembly (3) counter clockwise until the water supply is on.

The internal stop plunger assembly (3, 4, 5 and 8) can be removed by using a flat screwdriver and turning counter clockwise until the stop plunger assembly (3) is unscrewed from head (1). Discard the stop plunger assembly.

Insert the new stop plunger assembly (3) into the head (1), and using the flat screwdriver, turn clockwise until seated snug. (By hand only.) (Note: Lubricate the “O” Ring (4) with Lubriplate FGL-2 if needed.)
