Z100 FLOFORCE™ IMPROPER ROOF MEMBRANE INSTALLATION

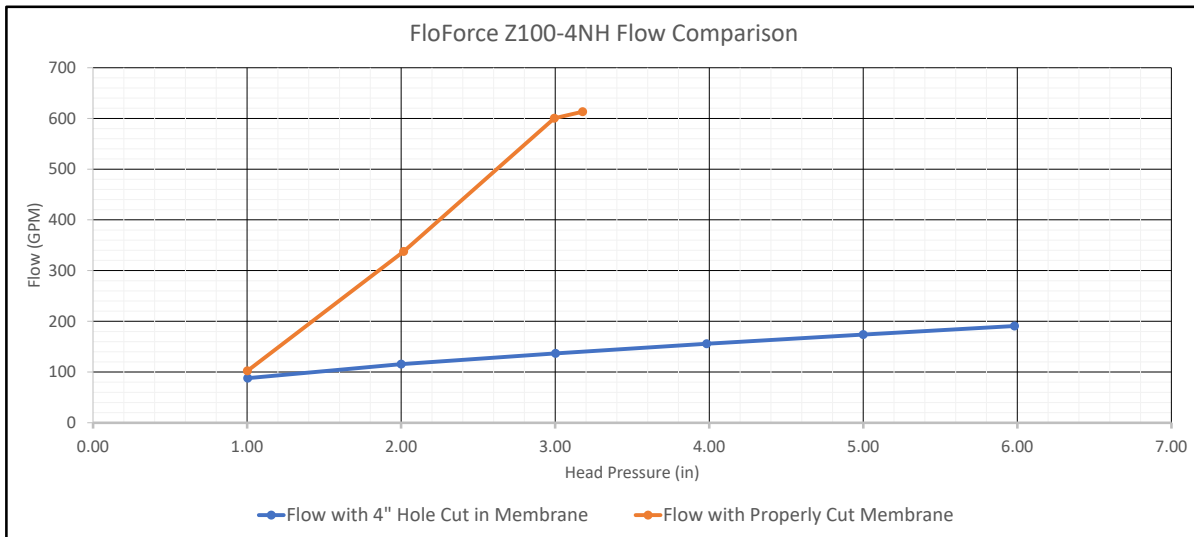
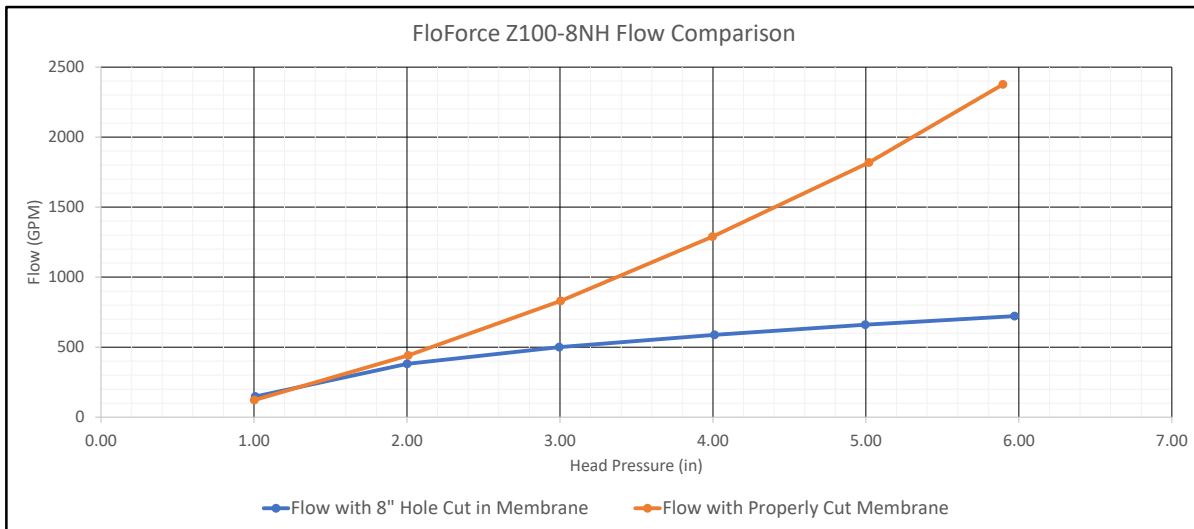
The flow graphs below represent a flow comparison between a properly and improperly cut roof membrane applied to a Z100 FloForce™ drain. The comparisons were conducted utilizing a 4" No-hub and an 8" No-Hub drain outlet. To simulate an improperly cut membrane, a 4" hole was cut into the membrane of the 4" drain sample and flow tested. Likewise, an 8" hole was cut into the membrane of the 8" drain sample and flow tested. The graphs display flow rate of the drain vs. ponding depth of water around the drain, utilizing a 4-ft Sch. 40 PVC vertical outlet drain pipe attached.

Proper roof drain installation is critical to the effects of how a roof drain performs. Specifically, the way the membrane is cut out to leave access to the interior drain body plays a critical role in how the water enters and flows through the drain. An improperly cut membrane can have phenomenal effects on the flow performance of a drainage system.

One common practice during the install of a roofing system is to cut a smaller temporary hole within the membrane, usually the same size as the drainage pipe, and continue the drain install accordingly. When the membrane and drain seal are clamped properly, the installer will sometimes leave the hole in the membrane as it is, with the intention of coming back later to finish cutting the membrane out. This step can oftentimes be forgotten, leaving an improper hole size in the membrane; the effects are devastating to flow performance of the drain.
