Model NR3XLEC LEAD-FREE*

Pressure Reducing Valve with Integral By-pass and Pressure Relief Valve
(1/2", 3/4" & 1")

REPAIR KIT INSTRUCTIONS

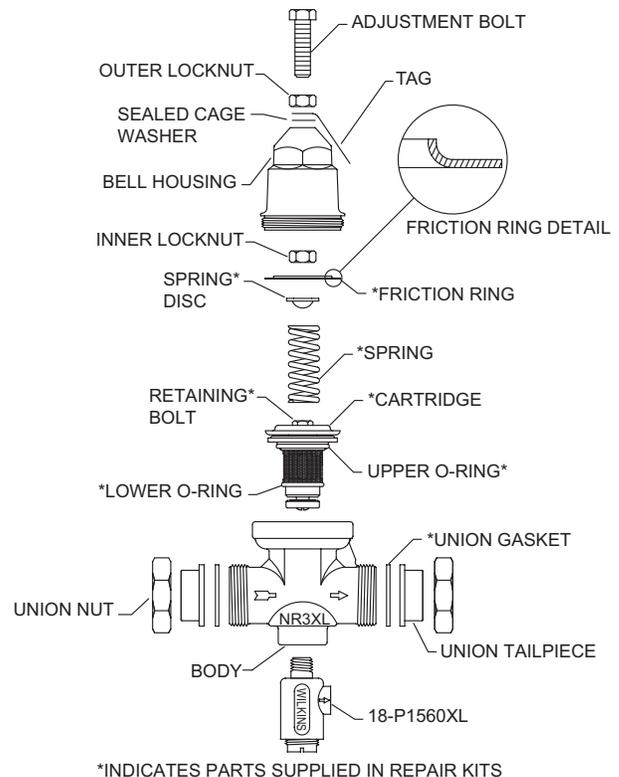
1. Note distance that adjustment bolt protrudes from bell housing. Loosen locknut on adjustment bolt, then turn adjustment bolt out of bell housing until free of spring tension.
2. Unscrew bell housing counterclockwise and remove spring, spring disc and friction ring.
3. Remove cartridge from regulator by gripping retaining bolt with pliers and pulling outwards away from body.

1. Open shut-off valve slowly and flush body and line of any debris.
2. Replace old cartridge assembly with new cartridge assembly. Prior to installation, apply a small amount of lubricant to cartridge o-rings. The cartridge is pushed into bore on body and seals against o-rings.

3. Install new spring, spring disc and friction ring. Make sure friction ring is installed with raised edge facing up (friction ring detail).
4. Replace bell housing by tightening clockwise (Be sure not to over-tighten.). Turn adjustment bolt clockwise until adjustment bolt touches spring disc.

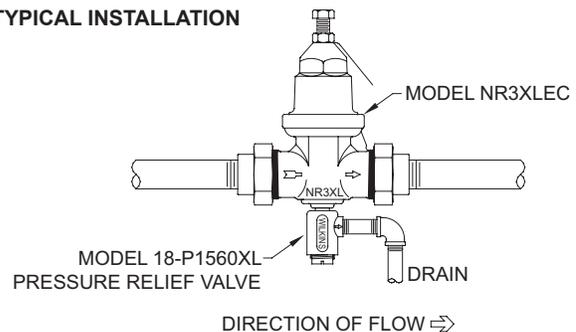
TYPICAL INSTALLATION

Regulators in series: Where the desired pressure reduction is more than a 4 to 1 ratio (i.e. 200psi to 50psi), multiple regulators in series should be installed.

Install valve in line with arrow on valve body pointing in direction of flow. Before installing reducing valve, flush out line to remove loose dirt and scale which might damage seal ring and seat. All valves will be furnished with stock settings to reduce to 50 psi. To readjust reduced pressure, loosen outer locknut and turn adjustment bolt clockwise (into bell housing) to raise reduced pressure, or counterclockwise (out of bell housing) to lower reduced pressure.
