ENGINEERING SPECIFICATION: ZURN Z1315

Prod. | Dwg. No. Z1315

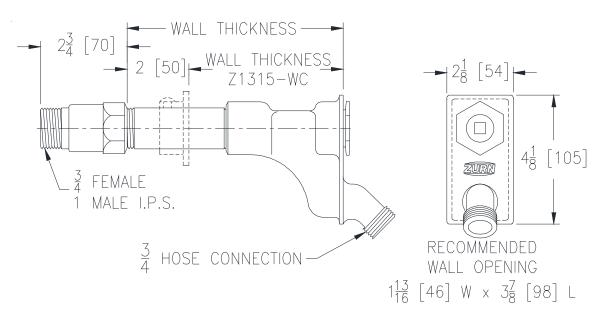
Wall Thickness Inches [mm]	Approx. Wt. Lbs. [kg]
4, 6, 8 [102, 152, 203]	6 [3]
10, 12 [254, 305]	8 [4]
16, 18 [406, 457]	10 [4]

Exposed, non-freeze wall hydrant, with bronze casing, all bronze interior parts, non-turning operating rod with free-floating compression closure valve, replaceable bronze seat and seat washer, and combination 3/4" female or 1" male straight IP inlet. Complete with operating key.

<u>ltem</u>	<u>Name</u>	<u>Quan.</u>
<u>5</u>	Operating Screw	<u>1</u>
<u>6</u>	O-Ring	<u>1</u>
<u>7</u>	Operating Coupling	<u>1</u>
<u>8</u>	Operating Rod	<u>1</u>
<u>16</u>	Removable Seat	<u>1</u>
<u>10</u>	Washer Guide	<u>1</u>
<u>11</u>	Washer (neoprene)	<u>1</u>
<u>12</u>	<u>Screw</u>	<u>1</u>
