COMMON COMPONENTS  
**Z1900-2/3/4-32/33**

12X12 [305X305] A.R.E SANI-FLOOR RECEPTOR 6 [152] SUMP DEPTH W/1/2 GRATE, 3/4 GRATE, FULL GRATE W/ OPENING AND ALUMINUM DOME STRAINER, WHITE A.R.C. ANTI SPLASH BOTTOM DOME STRAINER

Rev. B  
Date: 01/11/23  
C.N. No. 144899  
Patent [zurn.com/patents](http://zurn.com/patents)  
Prod. | Dwg. No. FS19

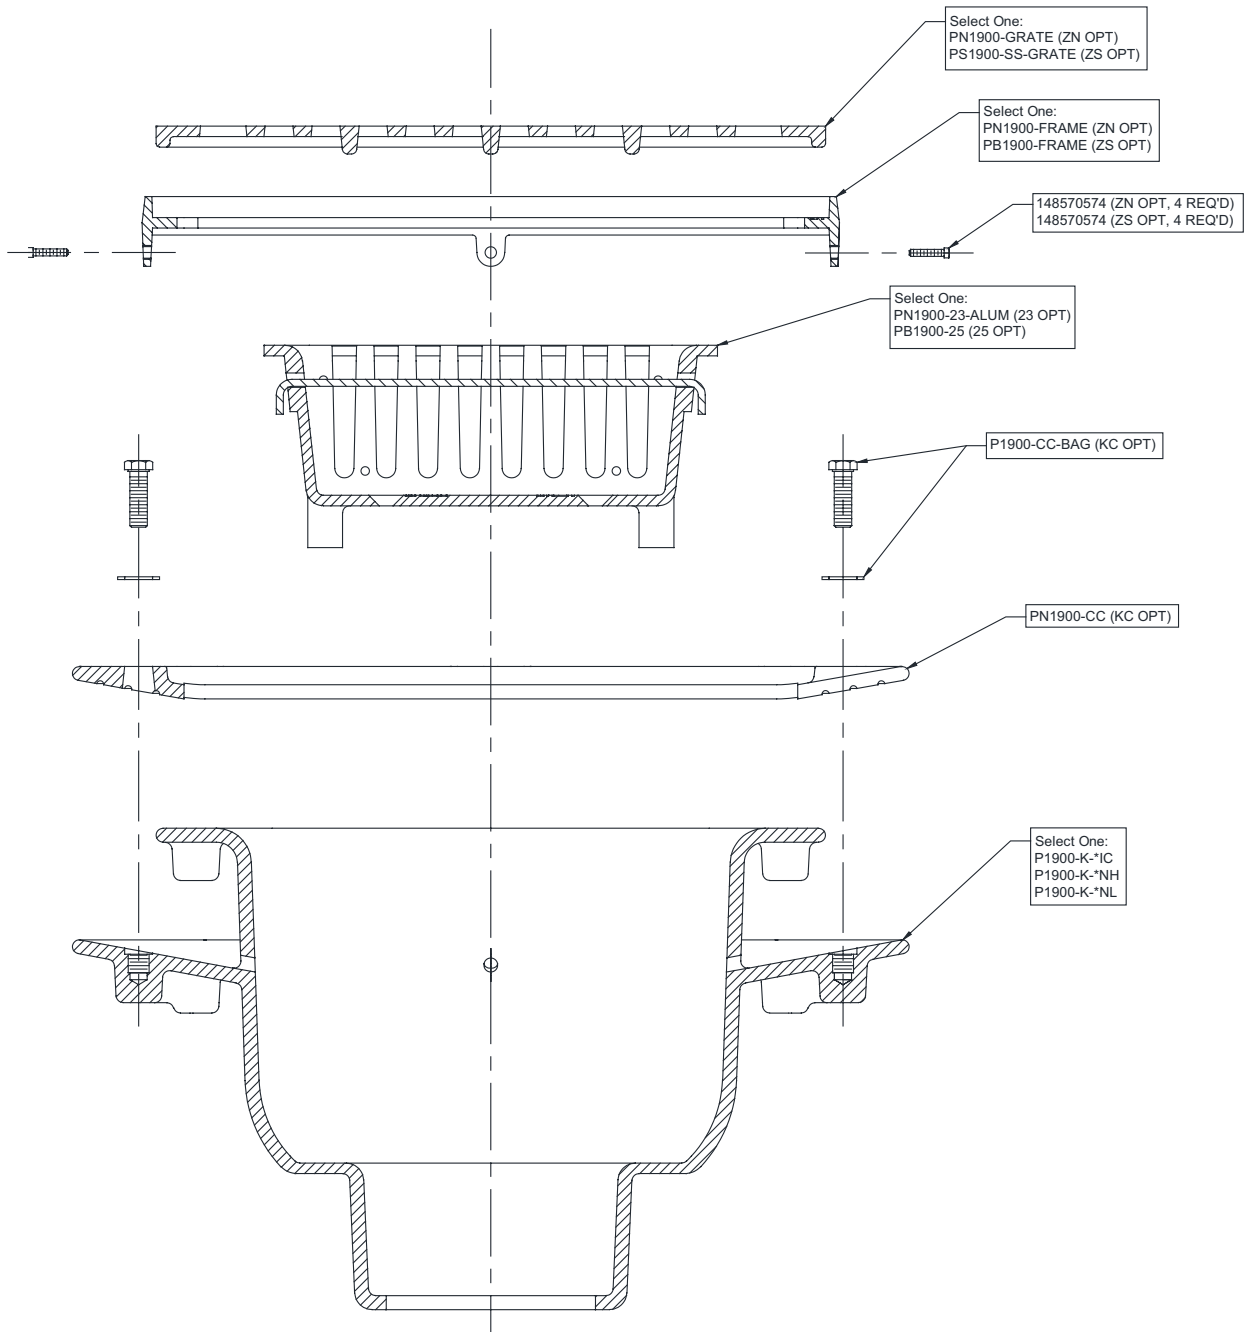
COMMON COMPONENTS  
**ZN1900/ZS1900-KC-23/25**

12X12 [305X305] A.R.E SANI-FLOOR RECEPTOR 6 [152] SUMP DEPTH W/ ANCHOR FLANGE W/  
SEEPAGE HOLES AND CLAMP COLLAR, ALUMINUM BUCKET, WHITE A.R.C.BUCKET
